Manhole Inspection Summary

Manhole # S15AA2002MH

Insp Date: **7/20/06 1:21 PM**

Location Address: **2102 SOUTH RD** Cross Street: **CARTERDALE RD**

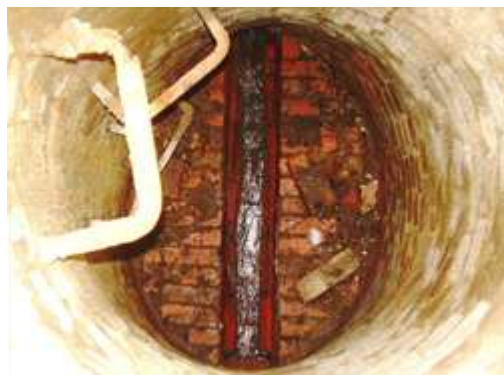
Top View

Corroded steps. Evidence of surcharge - Bench debris.

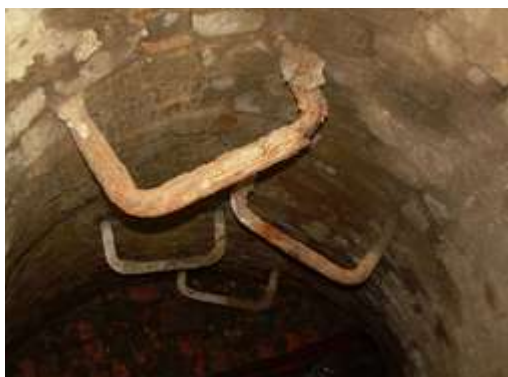
Defect

Adjustment, Corbel and Barrel infiltration.

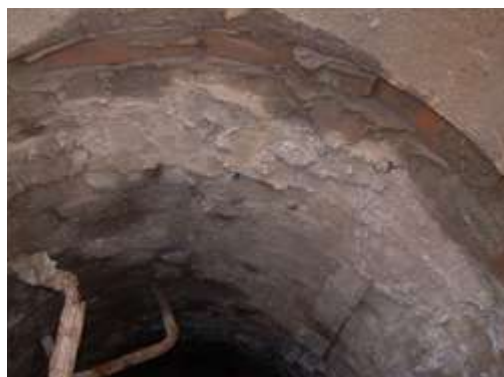
Defect

Frame leaks. Adjustment and Corbel infiltration.

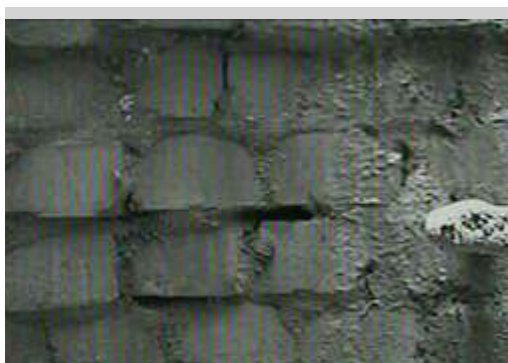
Defect

Barrel deterioration and infiltration.

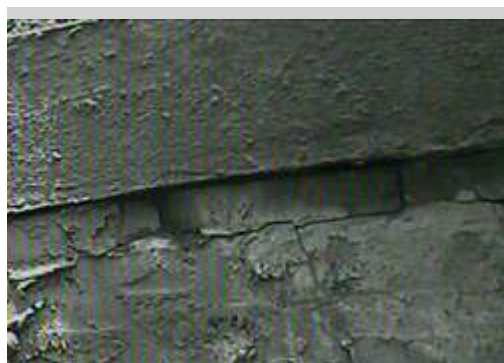
Defect

Frame leaks. Adjustment deterioration, loose brick and infiltration.

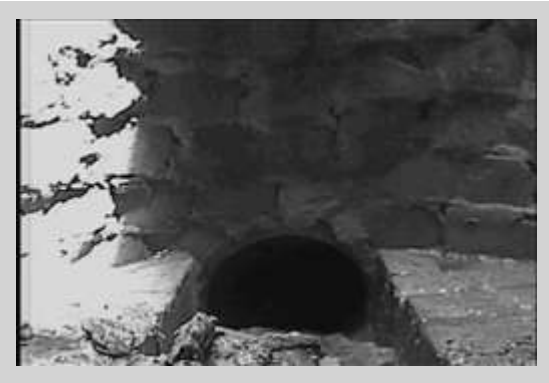
8 in. Circular Gravity Sewer Pipe Out @ 12 O'Clock

Barrel deterioration and infiltration.

Deposits: ☐ None ☒ **Mud** ☐ Sludge ☐ **Debris** ☐ Grease

Silt Depth: **2.5** (in.) Deposits Extent: **Medium**

Infiltration: **Evidence** Pipe Seal Cond: **Unknown**

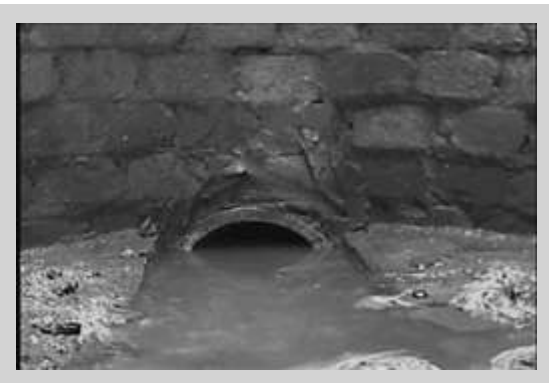
8 in. Circular Gravity Sewer Pipe In @ 6 O'Clock

Deposits: ☐ None ☒ **Mud** ☐ Sludge ☒ **Debris** ☐ Grease

Silt Depth: **6** (in.) Deposits Extent: **Heavy**

Comments **Channel full of debris- backing up flow- needs cleaning.**
